**Flood Control Project Maintenance  
Levee Inspections**

**Fall 2014 Levee Maintenance Deficiency Summary Report**

**Sacramento River Basin**

**Reclamation District No. 0150 Merrit Island**

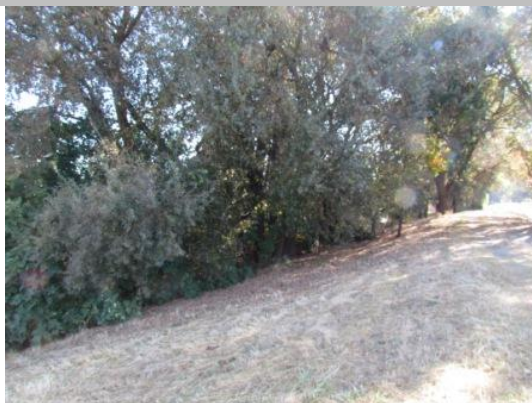
Photo 1 of 1 : FA\_2014\_RD0150\_17\_934\_20141021\_00100.jpg

LM Start	7.58	Rating **	M	Issue No.	934
LM End	7.58	Issue Type +	En	Location *	LS
Category	Earthen Levee			GPS Latitude/Longitude	
				Start	End
Item	Vegetation			38.403566 °	38.403566 °
				-121.538886 °	-121.538886 °
DWR ID	DWR_RD0150_03_s_2012_934				
Action/Comments					
Landscaping

Landscaping was blocking the visibility on the landside of the levee looking downstream.

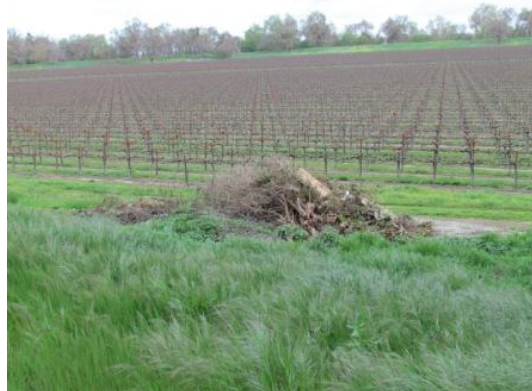
Photo 2 of 3 : FA\_2014\_RD0150\_17\_935\_20141021\_00102.jpg

LM Start	7.60	Rating **	M	Issue No.	935 (cont)	
LM End	7.60	Issue Type +	Ma	Location *	LS	
Category	Earthen Levee			GPS Latitude/Longitude		
				Start		End
Item	Encroachments			38.403795 °		38.403795 °
				-121.539205 °		-121.539205 °
DWR ID	DWR_RD0150_03_s_2012_935					
Action/Comments						
Prunings

Prunings were found on the landside of the levee looking upstream.

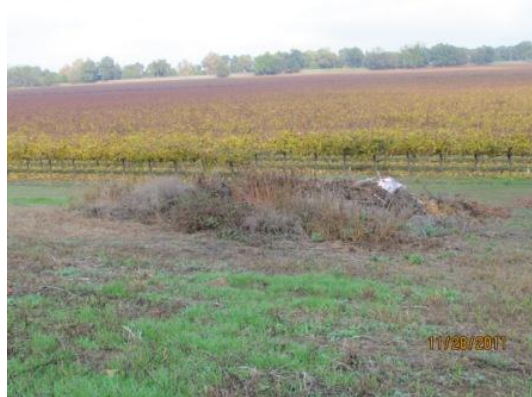
Photo 3 of 3 : FA\_2014\_RD0150\_17\_935\_20141021\_00103.jpg

Prunings were found on the landside of the levee looking upstream. This picture was taken during fall 2011 inspection.

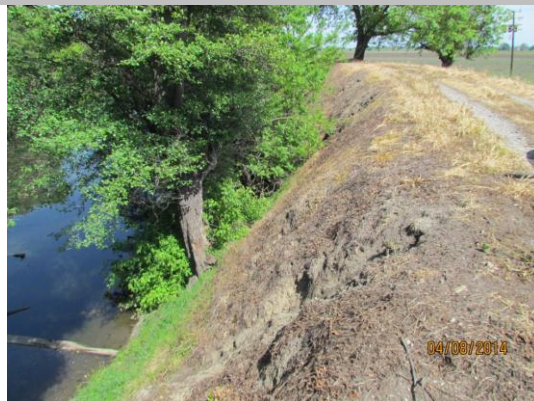
LM Start	<b>8.48</b>	Rating **	M	Issue No.	<b>67 (cont)</b>
LM End	<b>8.48</b>	Issue Type +	Ma	Location *	WS

Updated picture of the slope instability on the waterside shoulder looking upstream during spring 2014 inspection.

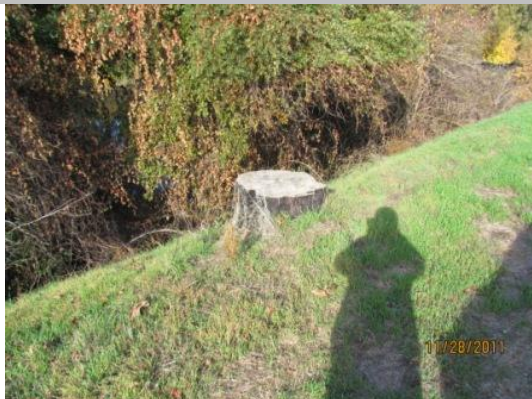
Photo 1 of 1 : FA\_2014\_RD0150\_17\_55\_20141021\_00049.jpg

A tree stump was found on the waterside of the levee looking upstream.

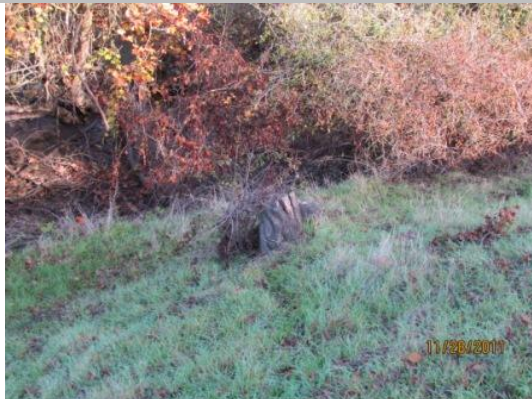
Photo 1 of 1 : FA\_2014\_RD0150\_17\_59\_20141021\_00053.jpg

A tree stump was found on the waterside of the levee looking upstream.

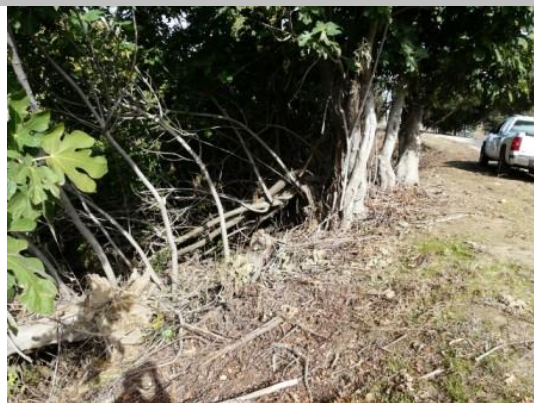
Photo 1 of 1 : FA\_2014\_RD0150\_17\_73\_20141021\_00075.jpg

LM Start	9.51	Rating **	M	Issue No.	73
LM End	9.51	Issue Type +	Ma	Location *	WS
Category	Earthen Levee			GPS Latitude/Longitude	
				Start	End
Item	Trim / Thin Trees			38.413169 °	38.413169 °
				-121.523707 °	-121.523707 °
DWR ID	DWR_RD0150_03_s_2012_73				
Action/Comments					
Trim and thin trees to allow visibility of the ground and room to flood fight.

Thin/trim trees to allow for visibility of top 20' of waterward slope at LM 9.51.
